General Document 37

**AIRCRAFT ACCIDENT INVESTIGATION AT ARL
THE FIRST 50 YEARS**

J.L. KEPERT

MARCH 1993

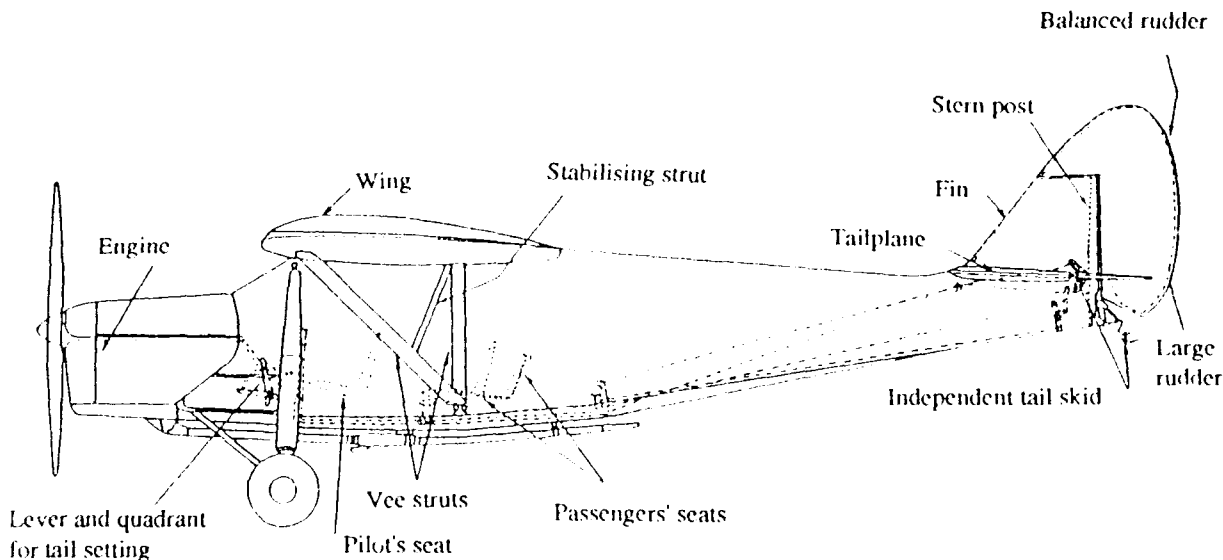
it easily met the load factor requirements of +5.5g and -2.75g specified for the normal category when the type certificate was issued in May 1930. Additional tests carried out by the RAE Farnborough supported this conclusion but indicated the desirability of fitting a stabilising bar to the forward leg of the vee strut; see Fig. 1. This mod was incorporated on 21 March 1932.

Fig. 1 DH Puss Moth showing location of stabilising strut

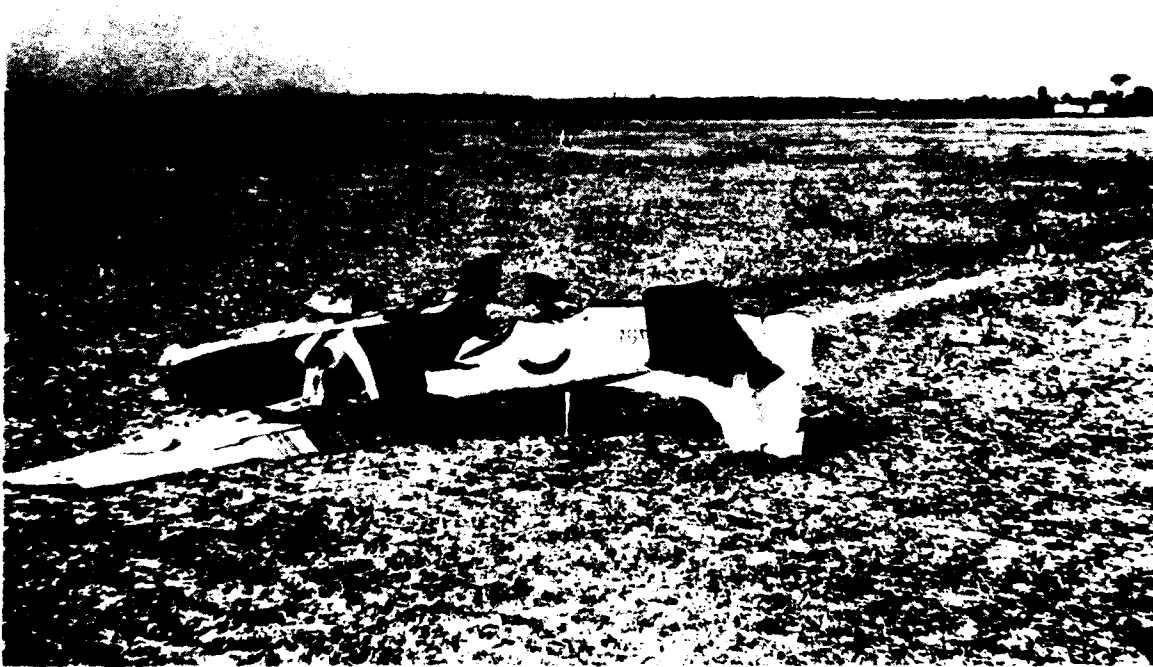
propeller blades showed these to have the classical smooth rearwards bend normally associated with low power output. A strip-down examination of the Rolls-Royce Merlin revealed that the flame traps were severely damaged. These flame traps were built up from sheets of copper alloy to form a fine mesh honeycomb within the intake manifold. A considerable amount of this material was found in the cylinders with pieces lodged under inlet and exhaust valves thus preventing them from closing. Further examination revealed a broken inlet valve seat and this probably induced the backfire which initiated failure of the flame traps.

Fig. 22 The wreckage of A68-123 with its detached propeller in the distance

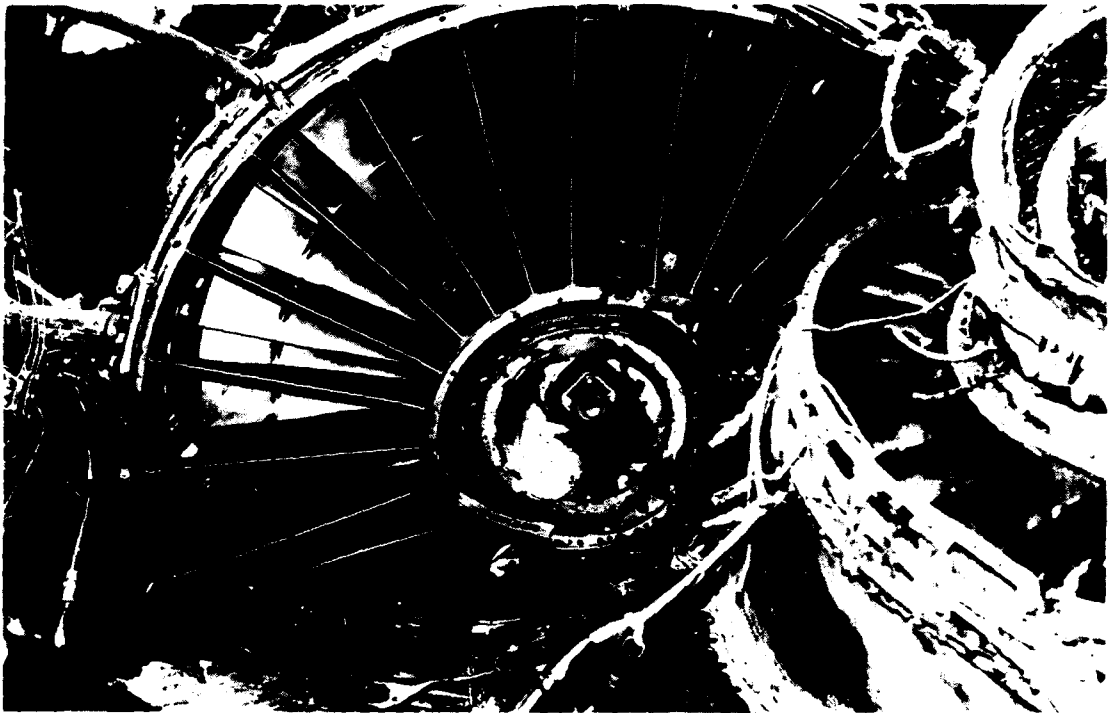
Fig. 26 Fan stage of engine No.1 from A20-103 showing minimal rotational damage to blades

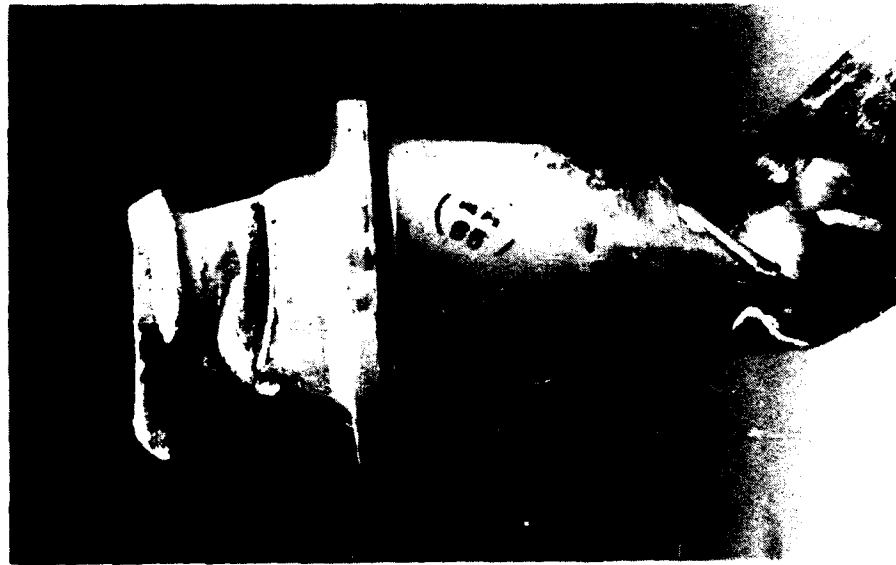
Fig. 52 **The failed drive shaft coupling from M38-02. Note the broken lugs at right caused by contact with the compressor drive drum, the cut in the end fitting made by the firewall, and the ground impact buckling of the shaft at left**
